JOHN D. MILNE DAM
CT 00058

PHASE I INSPECTION REPORT
NATIONAL DAM INSPECTION PROGRAM

AUGUST 1978

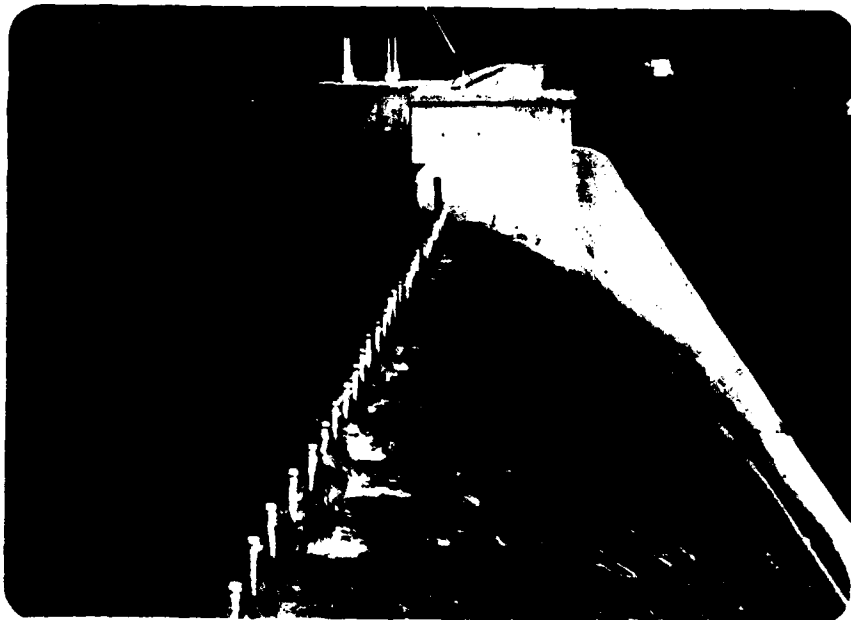
c. Visual Observations. The on-site inspection of the dam revealed no deviation from the design plans which would alter the hydraulic/hydrologic evaluation of the spillway outlet works. It should be noted, however, that the crest of the spillway has provisions for flashboards up to 2 feet high. Twelve-inch high by three-inch thick flashboards are in current use (June 22, 1978).

PHOTO #3: Crest of Spillway and Intake Structure looking East. Note Flashboards.
